## Glass Surface Staining

GG 001—2015-02-24

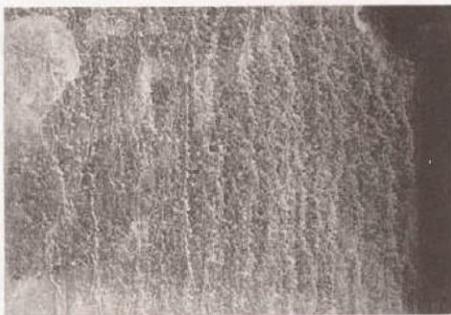
**Figure 3 – Reaction Contaminant**  
**Acid rain/masonry/glazing material**  
**run-down on the glass surface.**  
**Removal requires an acidic solution, or**  
**may not be practically possible.**
