## Glass Surface Staining

GG 001—2015-02-24

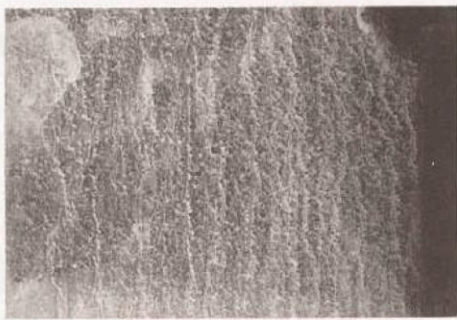
**Figure 3 – Reaction Contaminant**  
**Acid rain/masonry/glazing material**  
**run-down on the glass surface.**  
**Removal requires an acidic solution, or**  
**may not be practically possible.**

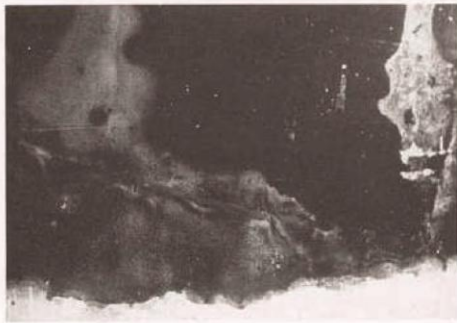
**Figure 4 – Surface Corrosion**  
**Glass corrosion is typically caused by**  
**prolonged exposure to high humidity**  
**and temperature and is often not**  
**removable.**
